CONSTRUCTING A CERTIFIED NET-ZERO HOME

Builder Success Story

Cedarglen Homes

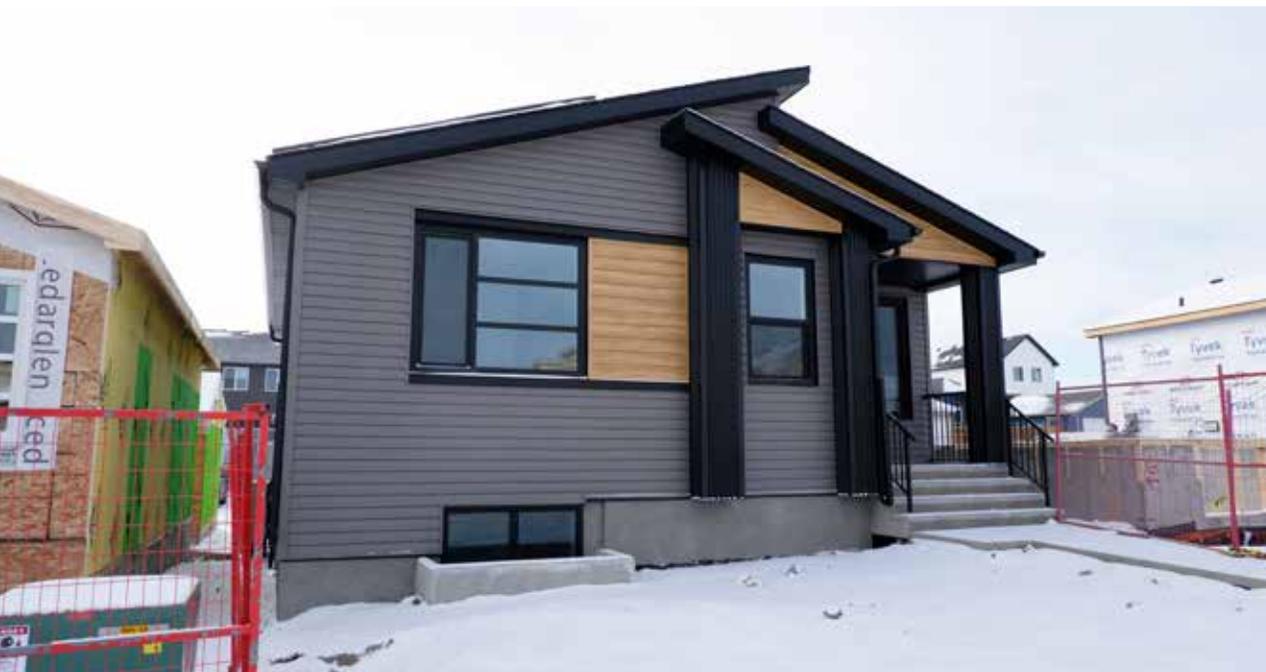
Figure 2: Exterior photo of the Net-Zero Home in January 2022.
Source: primary

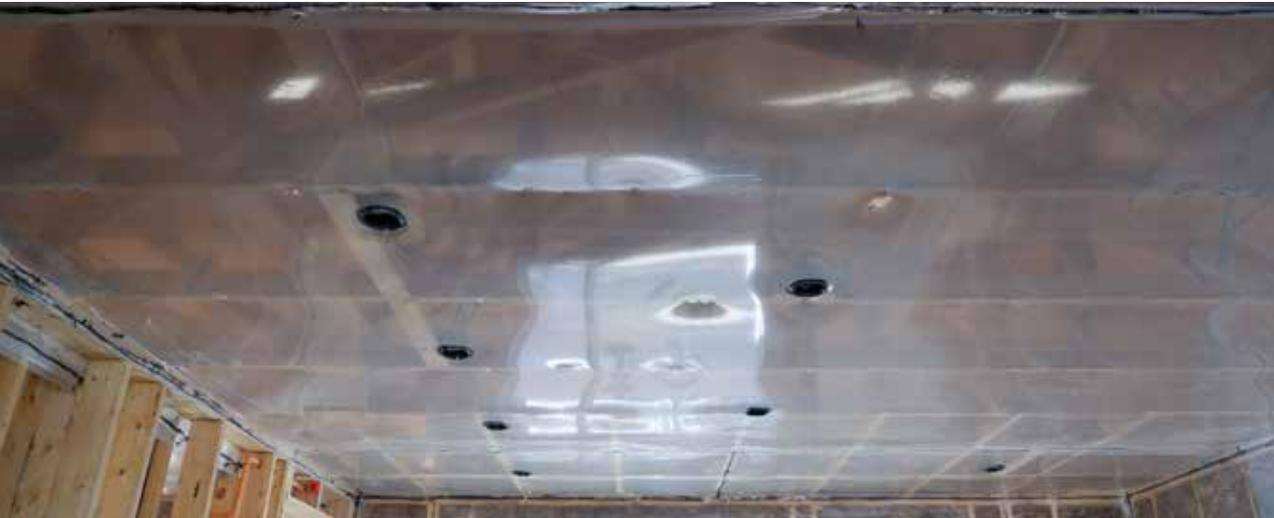
Figure 3: Photo of living room ceiling with pot-lighting taken during blower door test 1.
Source: primary

Air tightness throughout the entire home was increased and given special attention during the installation of the polyethylene vapour barrier. Figure 3 demonstrates the air-sealing of the pot-light system in the living room. This photo was taken during the first blower door test, performed prior to the installation of gypsum and finishes. The second blower door test was performed upon completion of the home.

Potential “problem spots” where air-tightness could be improved were identified during this first blower test, and were either mended on the spot or noted for later repair after the blower test was done. This assessment was performed by a Registered Energy Advisor (CACEA member) and Cedarglen team. Common areas where improvement was needed included around electrical and mechanical openings, membrane lapping, and assembly connections (e.g. wall to ceiling.)

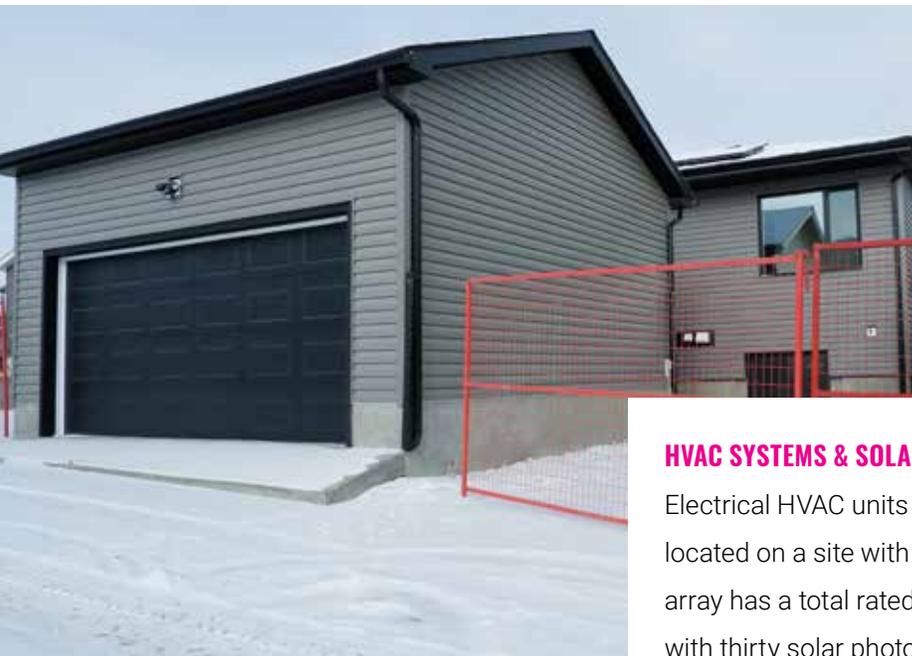
Figure 4: Photo of home from the rear with view of heat pump.
Source: primary

- A cold-climate Mitsubishi heat pump with electric back-up for extreme cold temperatures.
- A Lennox HRV unit with defrosting capability and sensible efficiency of 85%
- A 40-gallon (182 liters) Rheem heat pump water heater rated at 3.75 UEF (energy efficiency)

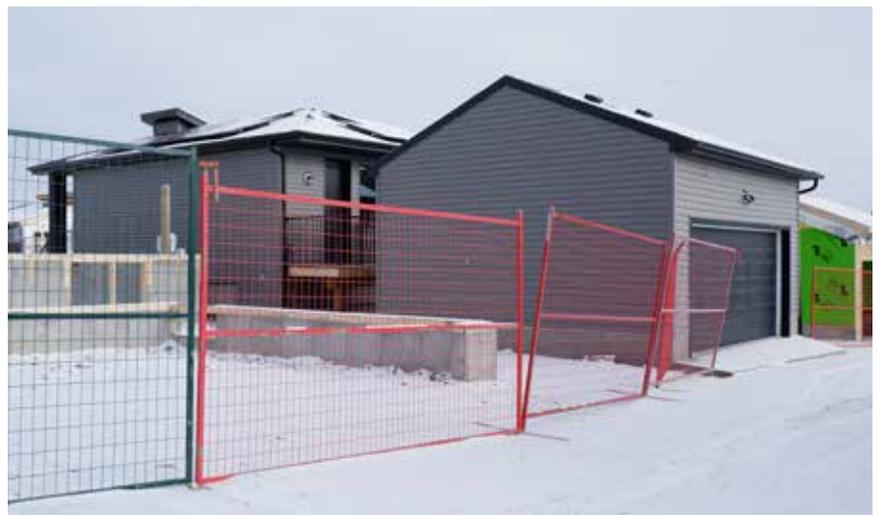
Figure 5: Photo of home from the side with view of solar array on roof.
Source: primary.

Electrical HVAC units were selected for the project. Despite being located on a site with a non-optimal solar orientation, the home's solar array has a total rated capacity of 10.8 kW. The system was designed with thirty solar photovoltaic (PV) panels. Six panels are located on the south-facing slope of the roof, fourteen on the east, and ten on the west. A solar inverter/generator of 7.6 kW size has been installed along side the solar array. No solar was installed on the detached garage unit.

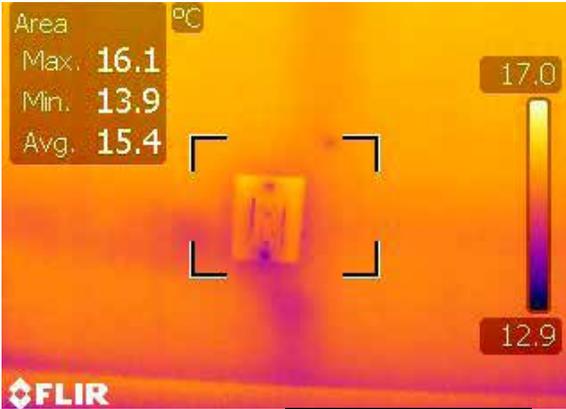
Figure 8: Minimal thermal penetration observed from framing surrounding an electrical fixture.
Source: SAIT

More minor thermal penetrations were observed at certain sections of the main-level exterior wall, such as where more framing was present around electrical fixtures. Overall, the home was observed as above average with fewer thermal penetrations than typical homes of similar size.

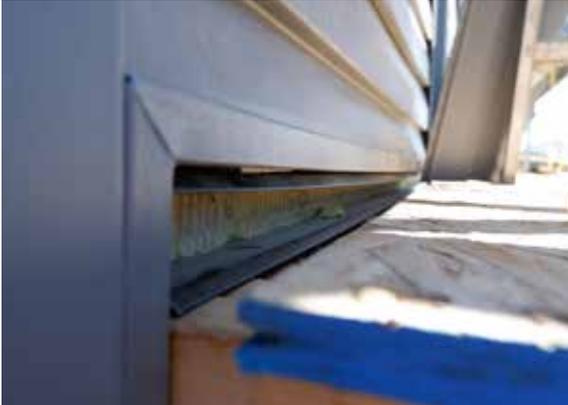
Figure 12: Photo of double flashing and insulation detailing around attached deck at rear of home.
Source: SAIT

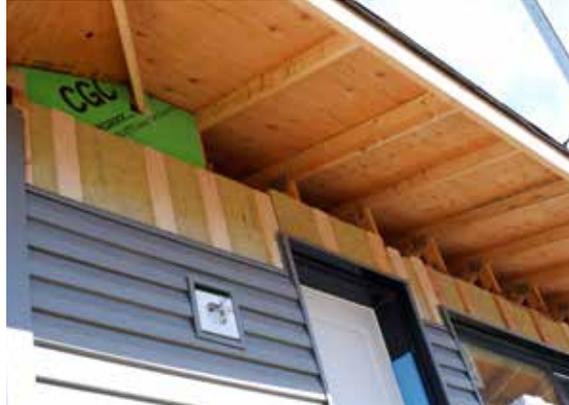
Figure 13: Photo of exterior 51 mm (2 inch) Thermafiber® RainBarrier® Plus High Compressive Plus (110) Mineral Wool Insulation and strapping below vinyl cladding.
Source: SAIT

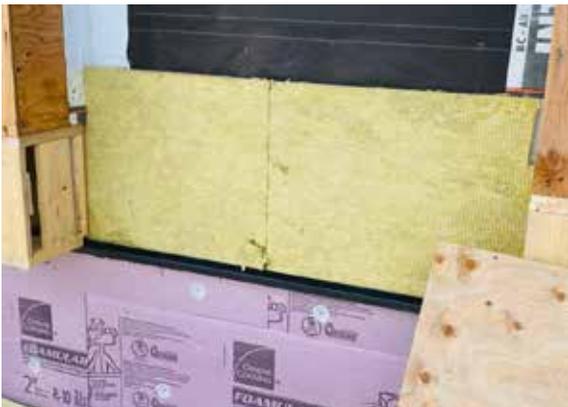
Figure 14: Below-grade to above grade wall transition showcasing 51 mm (2 inch) Thermafiber® RainBarrier® Plus High Compressive Plus (110) Mineral Wool Insulation and 51 mm (2 inch) FOAMULAR® C-300 Extruded Polystyrene Rigid Insulation.
Source: SAIT

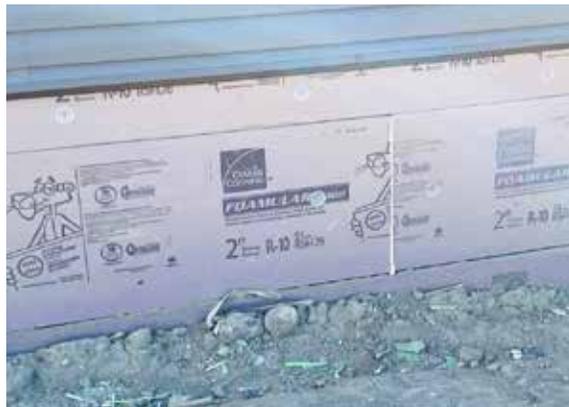
Figure 15: Below-grade exterior insulation showcasing 51 mm (2 inch) FOAMULAR® C-300 Extruded Polystyrene Rigid Insulation
Source: SAIT
